## Savannah Tip No: 22

### Savannah VG and XL Flap Adjustment.

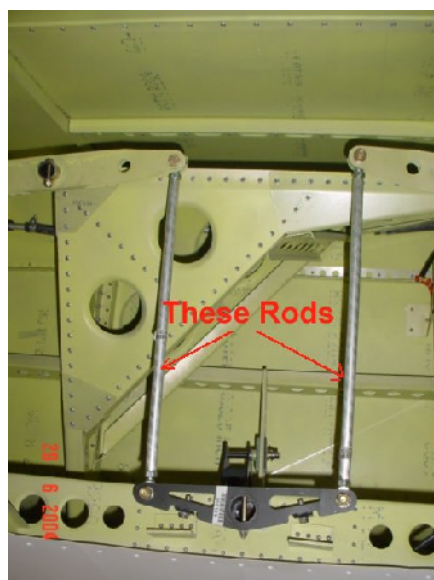
The ICP construction manual calls for the adjustment rods connected to the bell-crank (aileron horn) on the torque tube to be adjusted to their minimum length for the VG/XL models. This has the effect of reducing the AOA of the flaperons relative to the rest of the wing, and reducing the amount of flap available at the 2off flap settings. It also has the effect of moving the centre of lift forward, which then requires more down elevator trim for straight and level flight.

Aircraft with the control rods adjusted to the minimum length will not have enough down trim available at rearward CG's (such as when fully loaded) to neutralise the stick forces for hands off straight and level.

Consultation with ICP has resulted in ICP recommending that the control rods be returned to the original length to alleviate this problem.
