AeroKits...

Savannah Tip No 11; Many Savannah's have had the Stainless Steel Thrust Plate (mounted on the top of the front fork) come in contact with the upper diagonal tubes of the engine mount as a result of a hard landing or just taxiing over rough ground. This contact often results in dimpling of the underside of the steel engine mount tubes and or bending of the edge of the SS thrust plate.

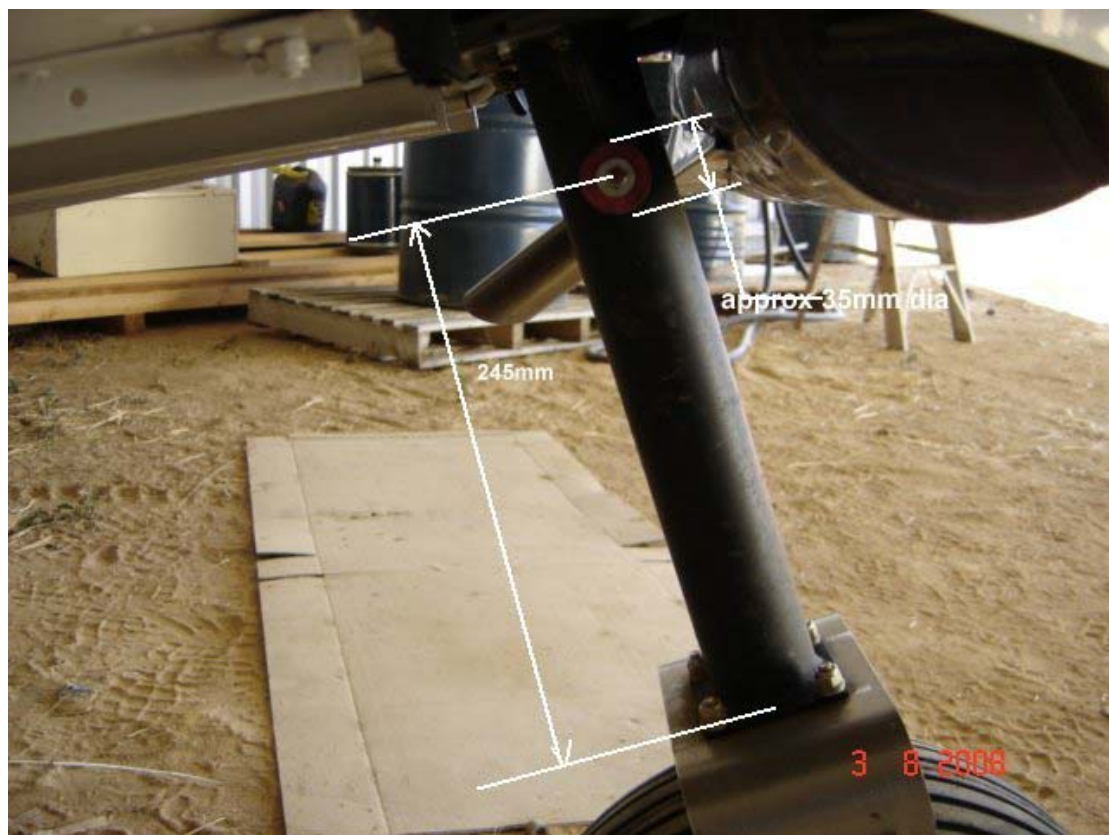
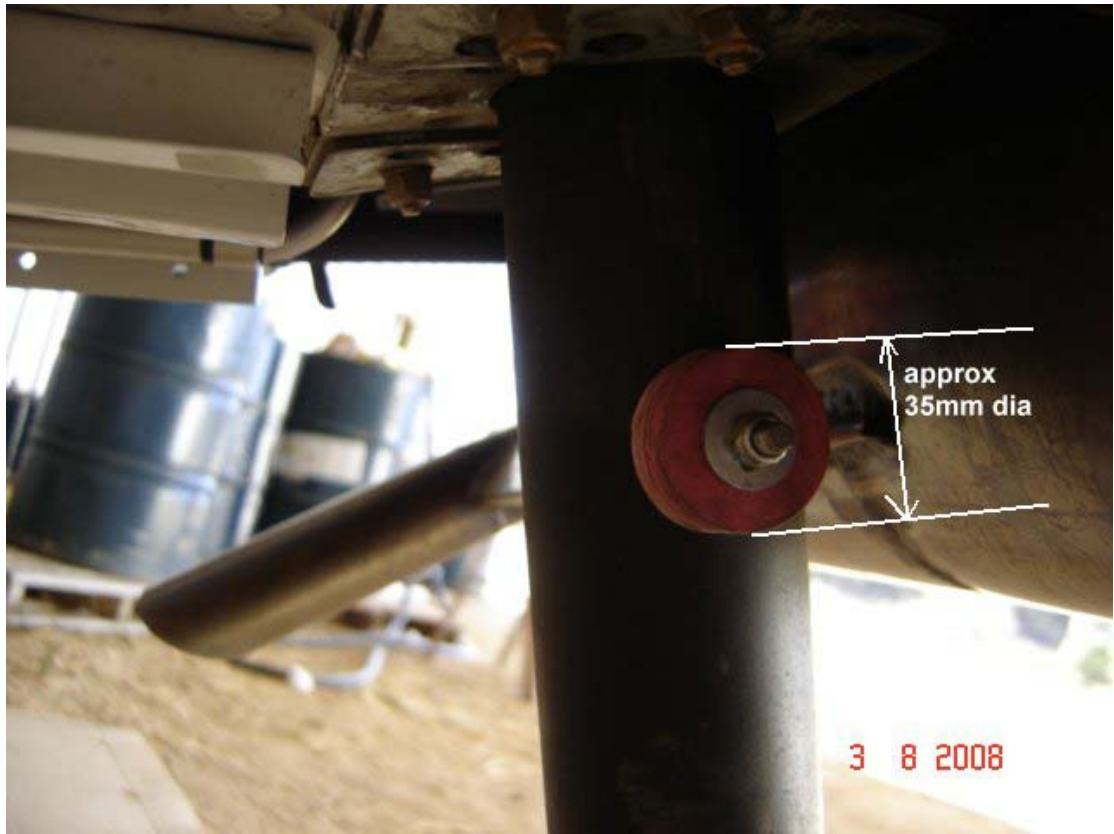
The only travel stop in the kits with this problem are the Steering Rods which bear against the top of the slot in the firewall at full travel. This can result in deformation of the slot or bending of the steering rods.

The latest kits have addressed this issue by supplying a Urethane bump stop which is bolted with a AN3 bolt through the front fork at the dimension shown in the photo below.
